TESTING
OF
TRANSPIRATION AIR COOLED TURBINE BLADES

VOLUME II

Report on Item Ic
Contract NOas 58-404-c

Curtiss-Wright

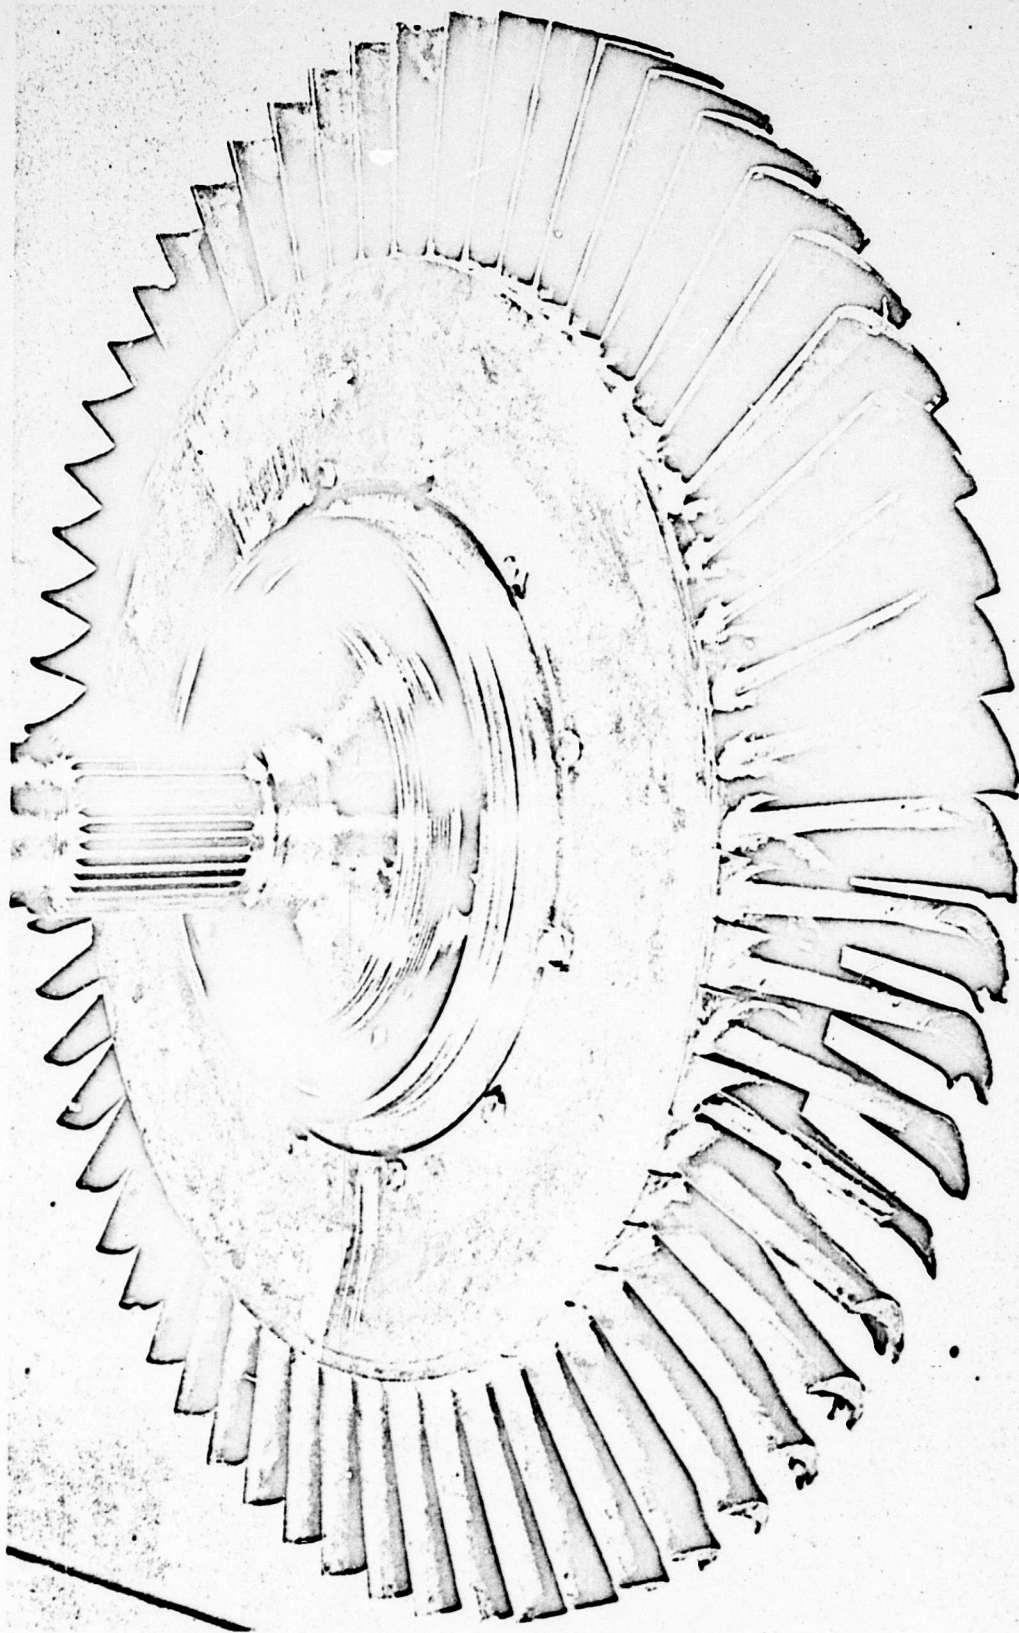
Figure VI-9

The initial tests were conducted to check cooling air flows, temperature distribution in the combustion chamber, and general test rig operation at relatively low turbine inlet temperatures. Difficulties were encountered with blades fabricated with the Rigmesh porous airfoil material. Upon attaining a little above 55% design speed one of the Rigmesh airfoils separated from the

blade supporting strut. Inspection of the blade revealed that poor brazing existed on the porous material due to oxide films in the porous material fibers. Replacement of the blade was made and further testing was carried on. In the next series of tests conducted loss of another Rigimesh porous airfoil occurred just above 80% speed (6050 rpm). Figures VI-9 and VI-10 shows the blade with the missing airfoil, and the minor resulting secondary damage to the remaining rotor blades. No damage was incurred to the transpiration cooled stator blades or any other engine component. Inspection of this blade also revealed poor bonding of the braze to the Rigimesh porous material, due to oxide films. It was decided at this time to replace all the blades made from Rigimesh material, approximately 50% of the wheel, with blades made from Poroloy material.

TRANSPARATION COOLED TURBINE ROTOR ASSEMBLY
SHOWING BLADE WITH MISSING AIRFOIL AFTER TEST (FRONT)

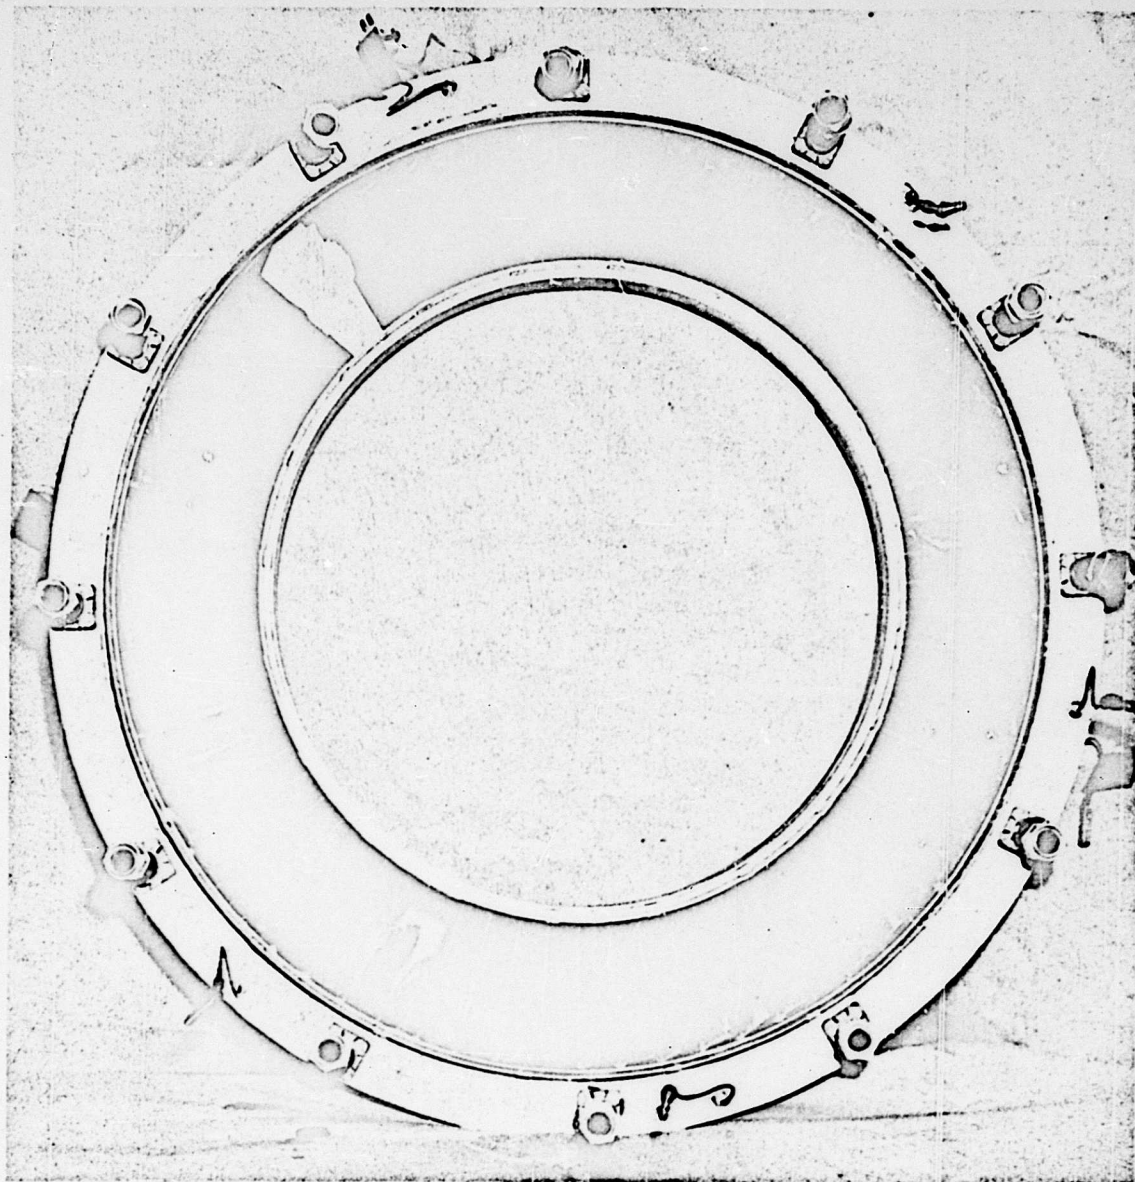
Figure VI-12

TRANSPIRATION COOLED STATOR BLADE ASSEMBLY
AFTER COMBUSTION CHAMBER TORCHING CONDITION (FRONT)

Another modification made was to utilize external cooling air for the stator blades and exhaust duct to eliminate the uneven mass flow through the combustion chamber, basically the six extremely "hot spots" which caused the failure of the stator blades. This could have been corrected by modifying the method of bleeding this cooling air; but again, time did not allow the incorporation of the necessary modifications for better distribution of cooling air bleed. The source of external cooling air bleed was portable 600 FM constant displacement compressors.

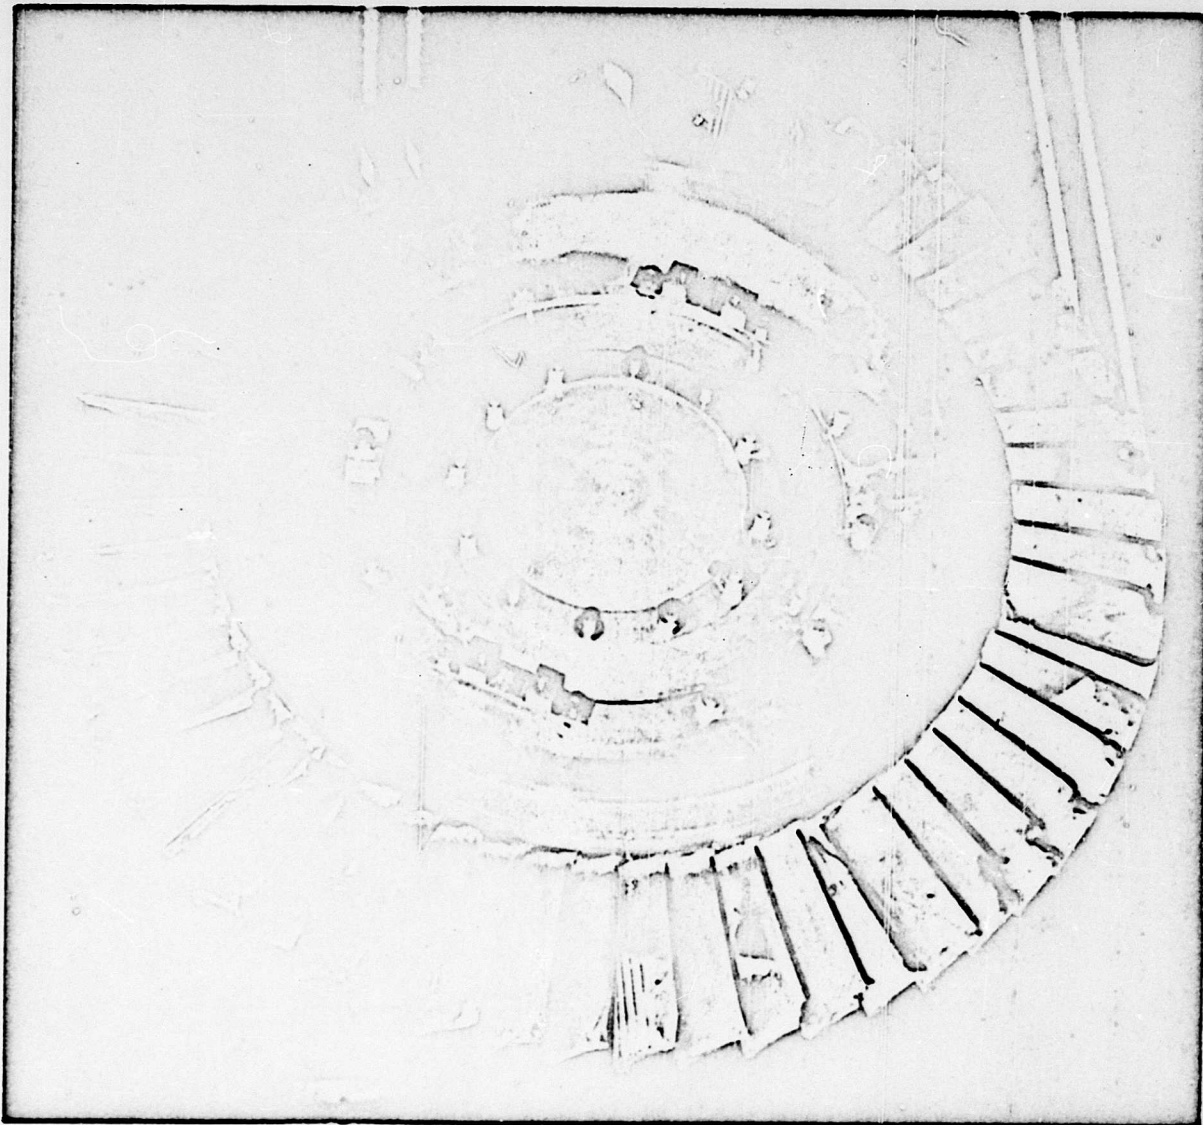
Figure VI-13

As a result of the torching condition in the combustion chamber and the burning through of the stator blades the rotor assembly was damaged beyond repair. Figures VI-13 and VI-14 show the damaged incurred on the turbine rotor assembly.

**TRANSPIRATION COOLED TURBINE ROTOR ASSEMBLY
SHOWING DAMAGES RESULTING FROM BURNED STATOR (REAR)**

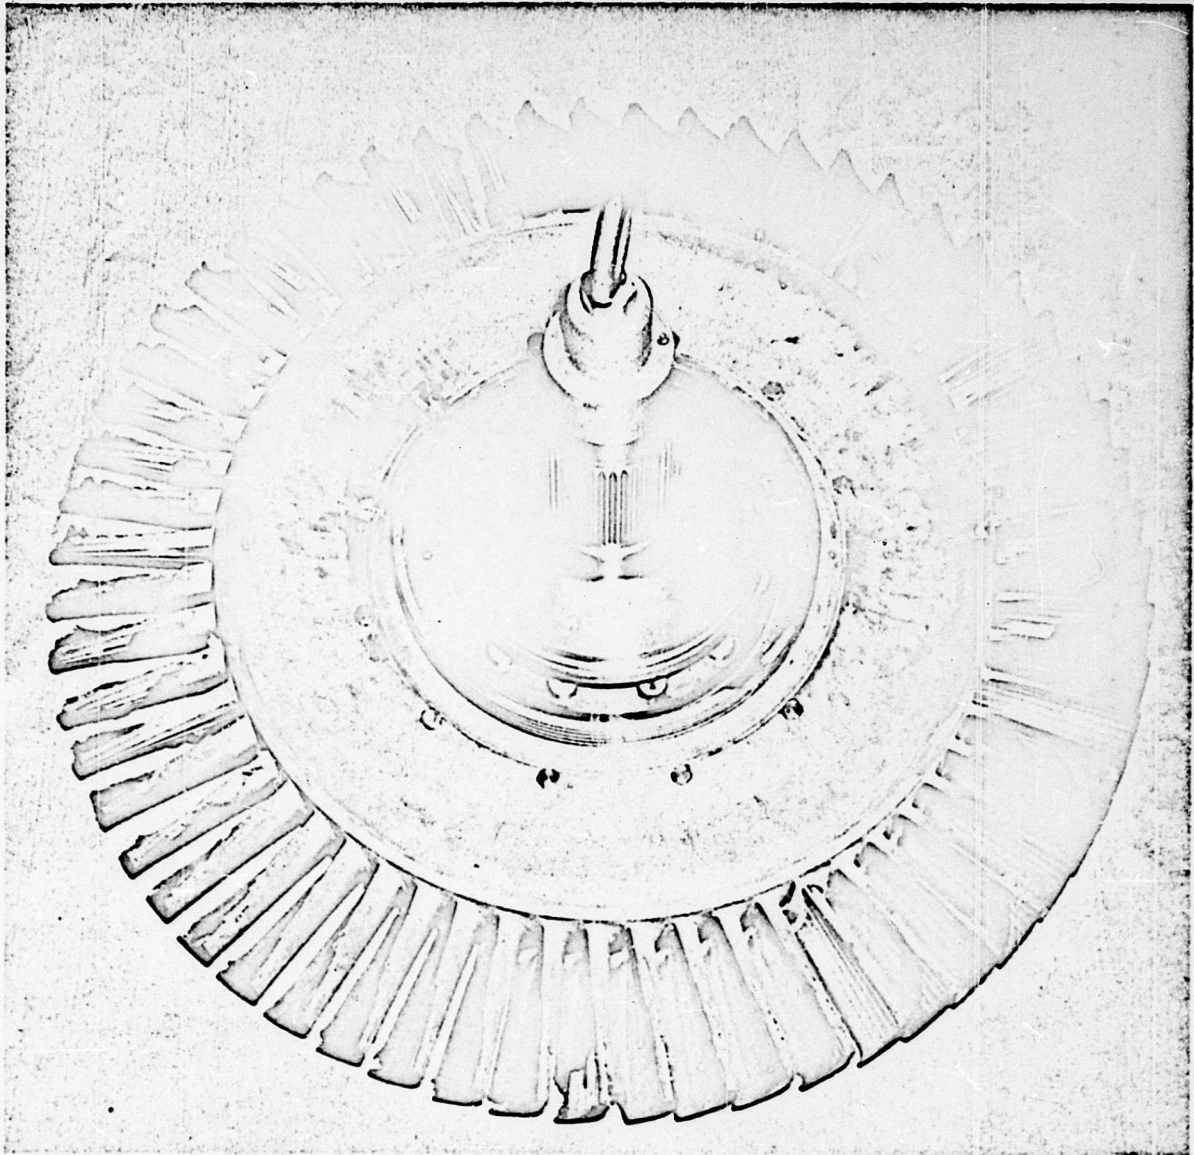
Figure VI-14

TRANSPARATION COOLED TURBINE ROTOR ASSEMBLY
SHOWING DAMAGES RESULTING FROM BURNED STATOR (FRONT)

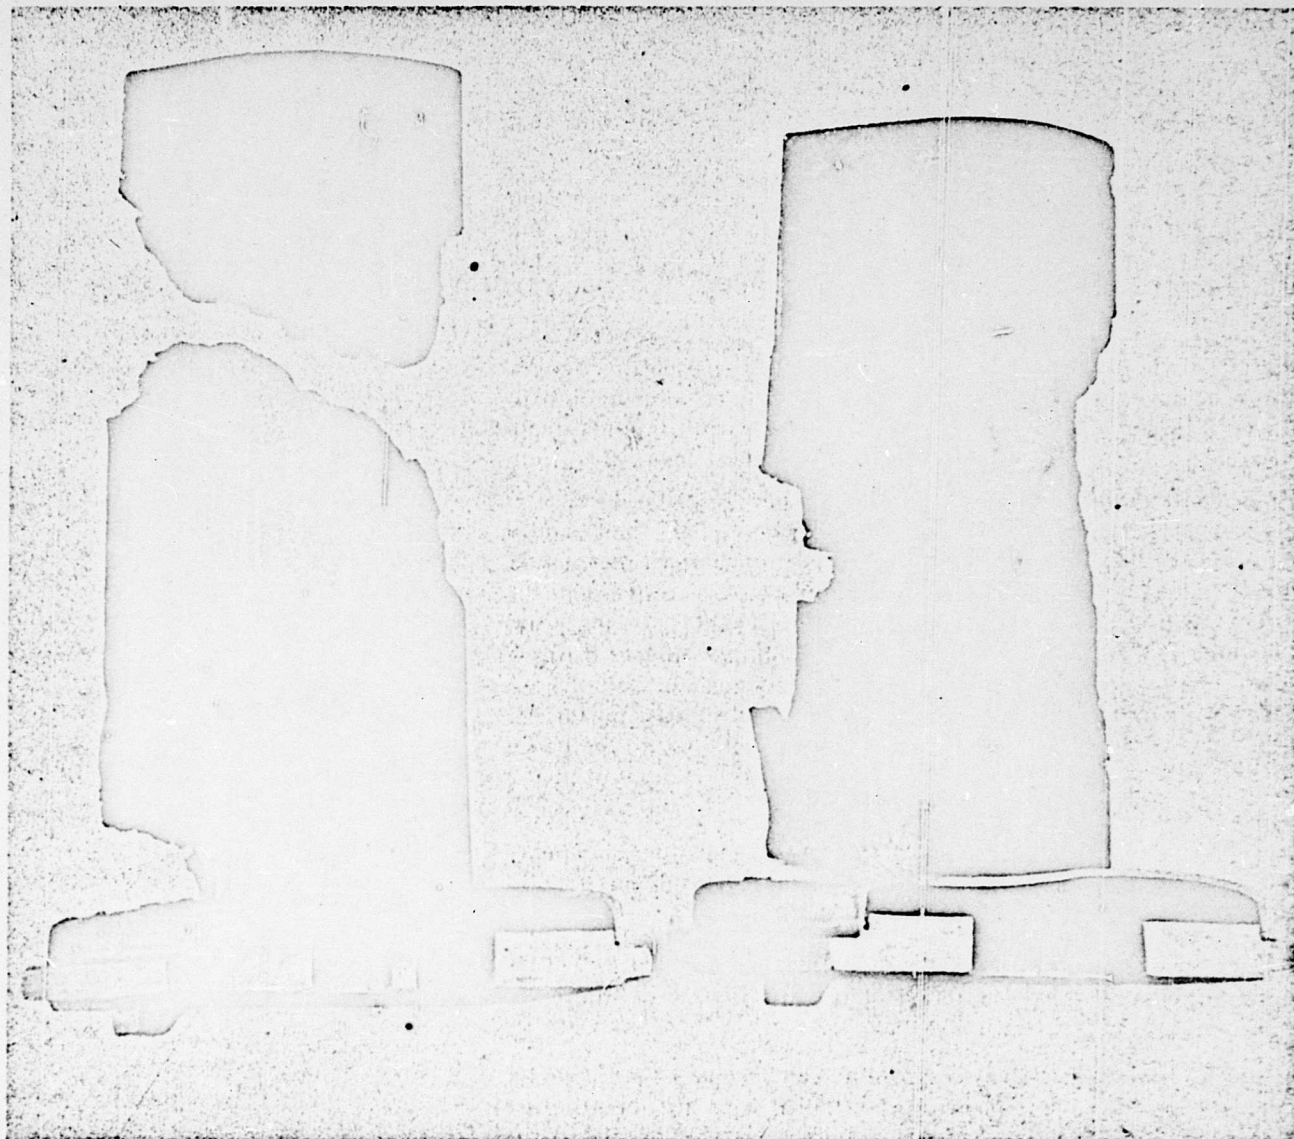
Figure VI-15

A close-up view of the burned stators is shown in Figure VI-15. Figure VI-16 shows the typical secondary damage done to the remaining stator and rotor blades. It can be noted that the condition of the blades in the areas undamaged by secondary effects is quite good.

**TRANSPIRATION COOLED STATOR BLADE
FAILED BY COMBUSTION CHAMBER TORCHING AND COOLING AIR STARVATION**

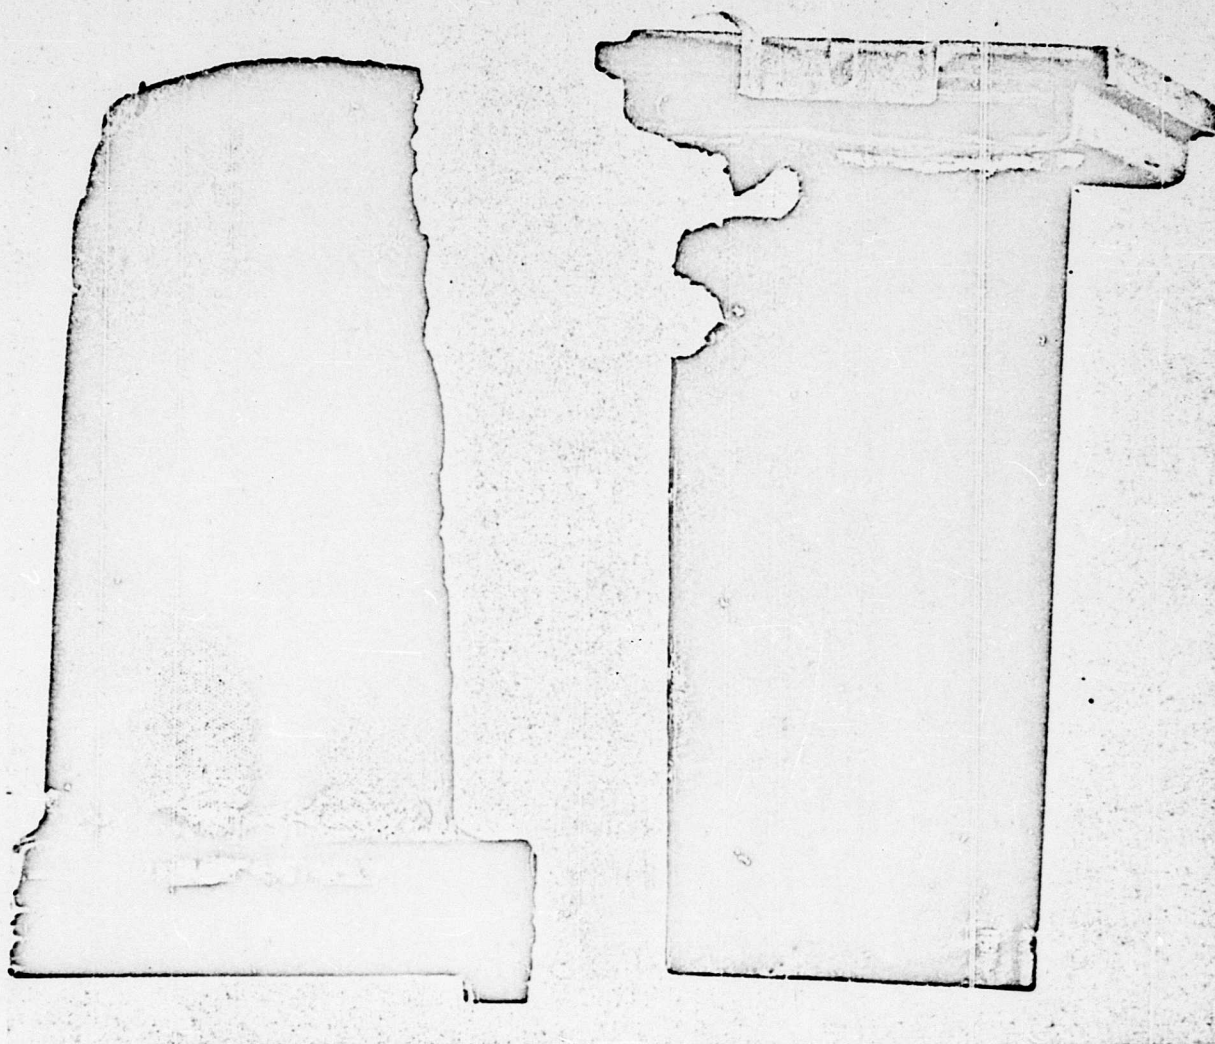
Figure VI-16

Closer observation of the blades revealed that excessive cooling was occurring on the suction side of both the rotor and stator blades. In the theoretical heat transfer analysis discussed in Section I, Volume I of the report the pressure distribution around the blade periphery was determined by the use of an analog. However, due to the fact that this was an entirely new turbine design only one section, the mean section of the blades, was analyzed in this manner for chordwise pressure distribution. As the spanwise pressure profile was assumed to obtain the chordwise pressure distribution without any background on this particular turbine it was felt that the accuracy of any pressure profile determined by the analog method would be highly questionable at any other section than the mean.

TRANSPARATION COOLED TURBINE BLADES
SECONDARY DAMAGE FROM BURNED STATOR BLADE

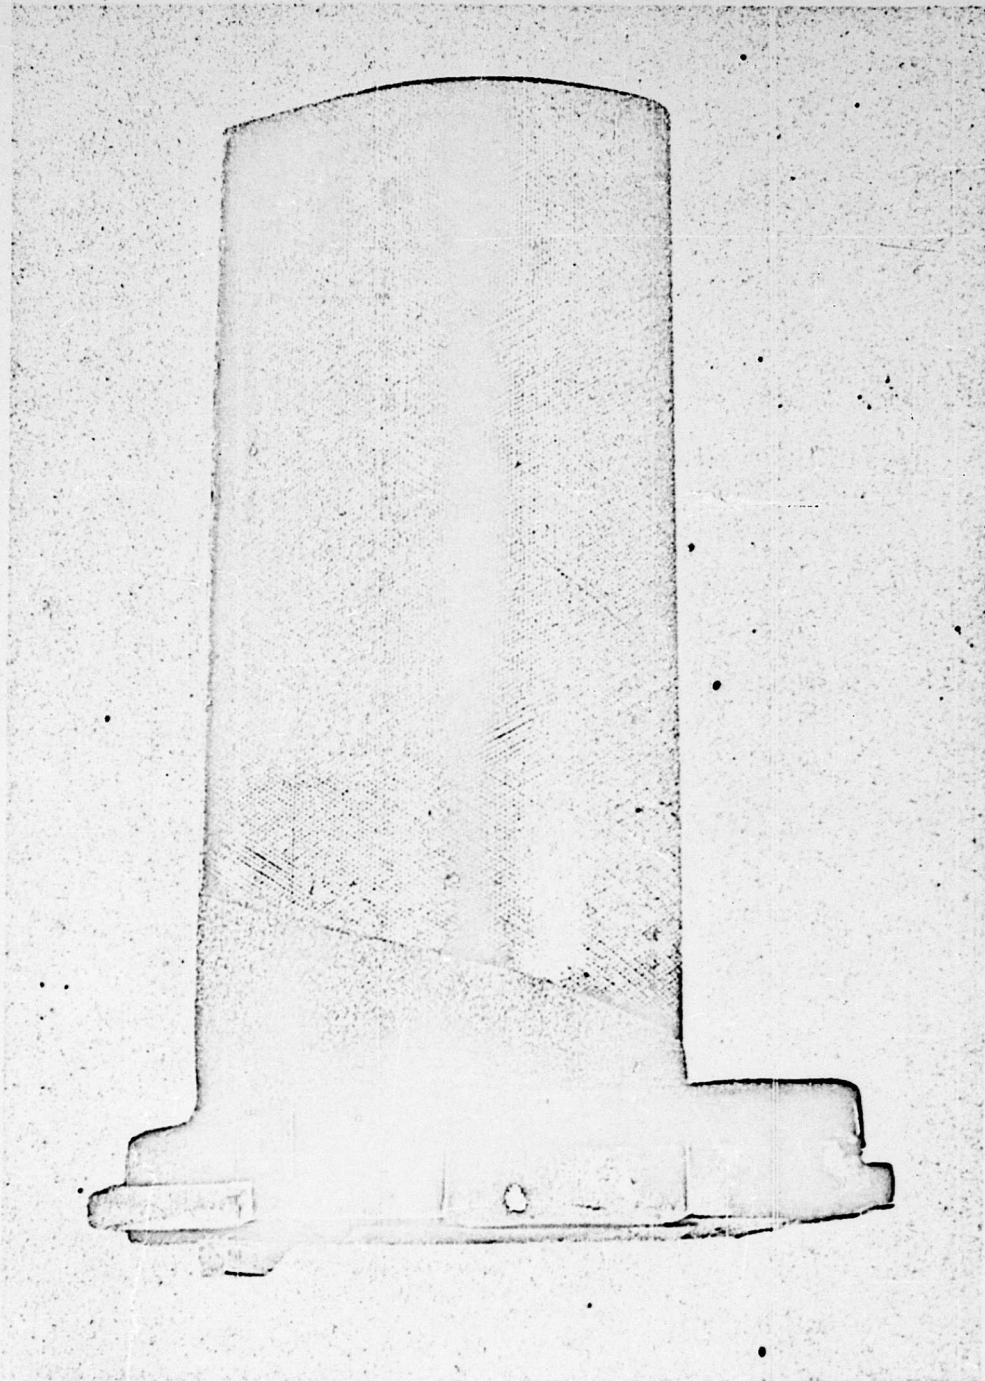
TRANSPIRATION COOLED STATOR BLADE
METALIZED ON THE SUCTION SIDE AT THE ROOT

In order to improve the cooling air distribution on the blades it was felt that masking of the blade was necessary in the areas that appeared to be receiving more than the required amounts of cooling air. The method evolved to mask these cooler areas was by utilizing a metal spray technique generally known in industry as "metalizing". By this metalizing technique it was possible to mask the desired areas and distribute cooling air to the hotter portions of the blade. Laboratory checks of these metalized areas showed that the areas were still somewhat porous. Again time did not permit a detailed study, but an investigation in the future would be of value to possibly use this method to obtain variable permeability over the blade airfoil surface area. Figure VI-17 shows a stator blade that has been metalized on the suction side at the root of the airfoil.

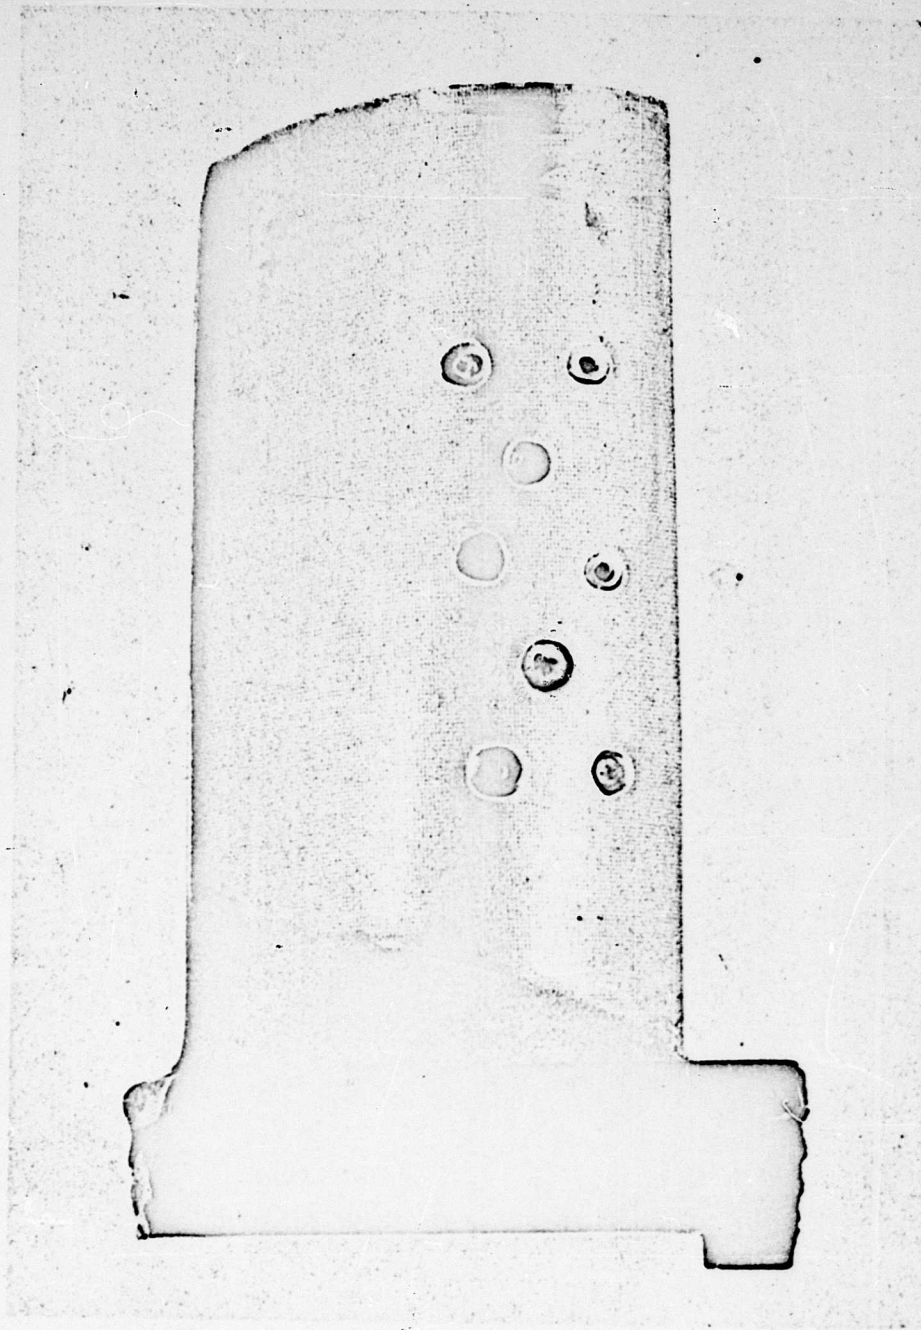
Figure VI-18

TRANSPARATION COOLED ROTOR BLADE
PLUG WELDED AIRFOIL AND METALIZED ROOT

In order to conduct further testing it was necessary to use the 'Rigimesh' rotor blades. As discussed previously all of these blades had been removed from the rotor assembly as the bond to the porous airfoil was questionable due to the dirtiness of the porous material. Plug welding of the porous airfoil skin to the blade strut was attempted as a means of salvaging these blades, as shown in Figure VI-18. It can be seen in this figure that the plug welding created dimples in the airfoil surface that

would disturb the turbine aerodynamics. However, it was felt at this time that this was the only way further testing could be conducted. Although engine performance would suffer, the objective of demonstrating the feasibility of transpiration cooled turbine blades at elevated turbine inlet temperatures could still be attained. Metalizing at the root section on the suction side of the rotor blade was also done to improve cooling air distribution, and is also shown in Figure VI-18.

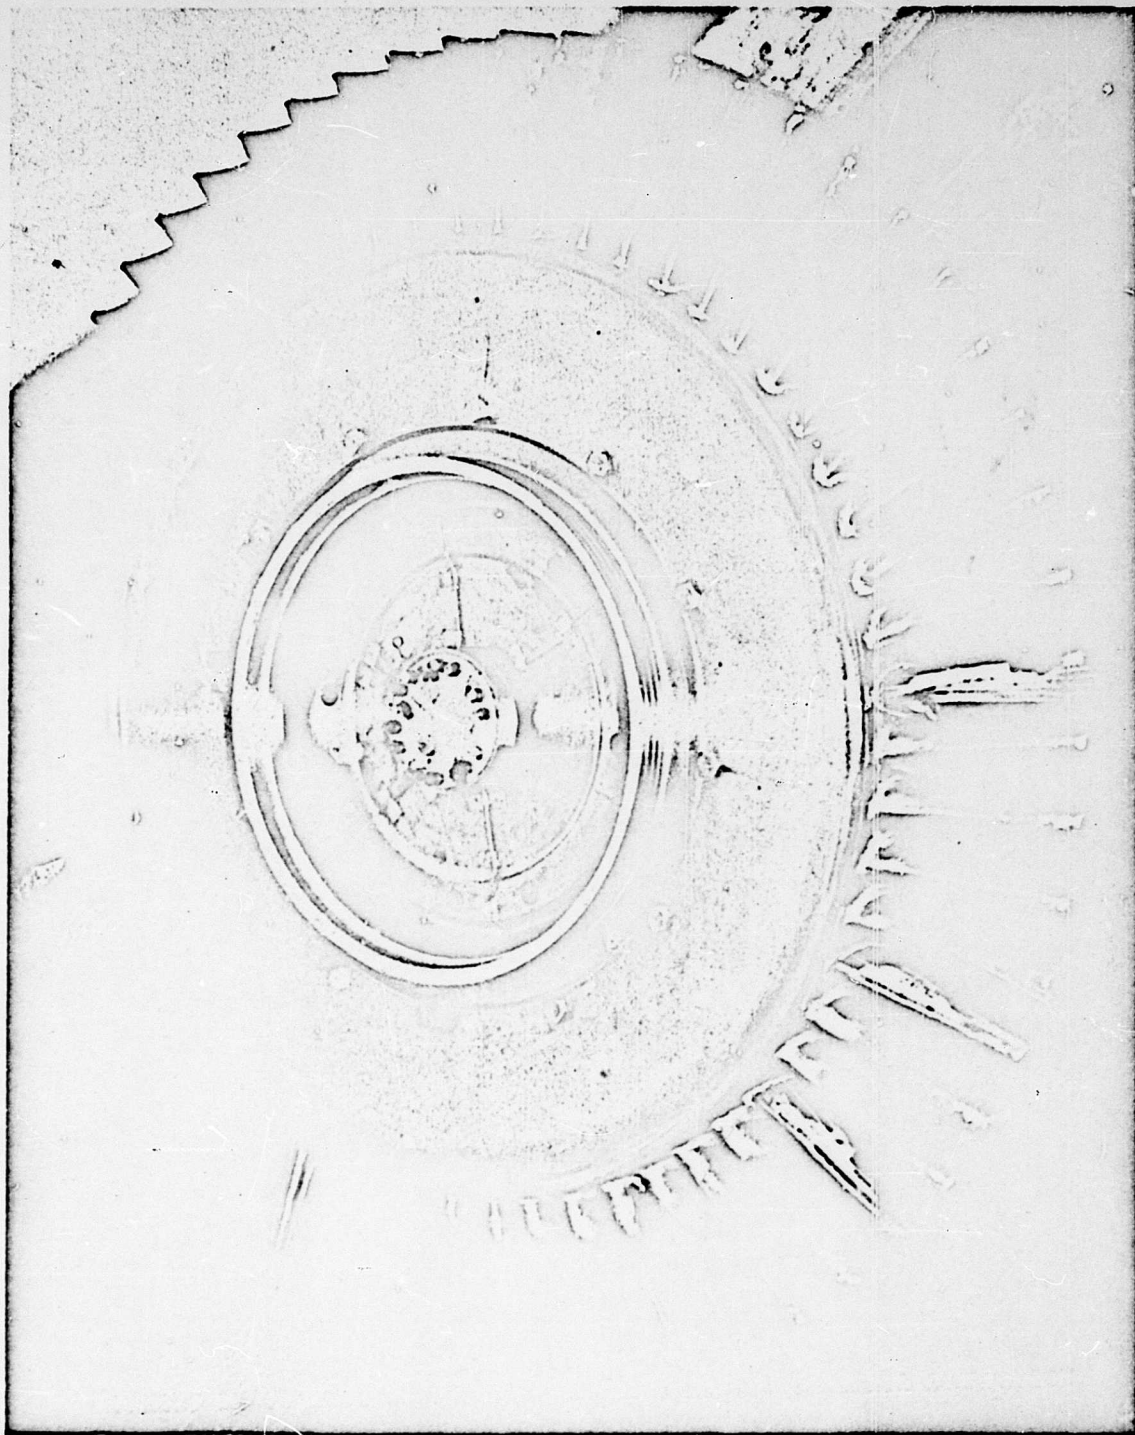
Figure VI-19

The engine test program was terminated because as the rated speed point was being set at approximately 2200°F turbine inlet temperature, engine surge was noted, indicating an engine component had failed. Inspection of the engine, after shut-down, showed the turbine rotor shroud had broken loose from the engine casing, and it was resting (wrapped around) the turbine rotor stage. The turbine blade tip areas showed signs of severe tip rub. The airfoil skins of two turbine rotor blades were completely torn loose, and damage was noted on the remaining airfoils. An analysis of the damaged rotor, Figure VI-19, shows that the blades were running relatively cool, and discounting the secondary damage, were in excellent condition considering the severe conditions encountered. Figure VI-20 shows the turbine shroud, after it was removed (unwrapped) from the rotor stage. Analysis of the part indicated failure was caused by, primarily, faulty welding of the shroud. While this was the immediate cause of the failure, the extreme distortion of the shroud noted in previous running leads to the belief that the true cause of failure was the improper heat treatment of the shroud. As the temperature level of the engine was increased, the distortion increased, until finally the attaching lugs failed, loosening the shroud from the engine casing.

TRANSPIRATION COOLED ROTOR ASSEMBLY
SHOWING DAMAGE INCURRED IN LAST TEST

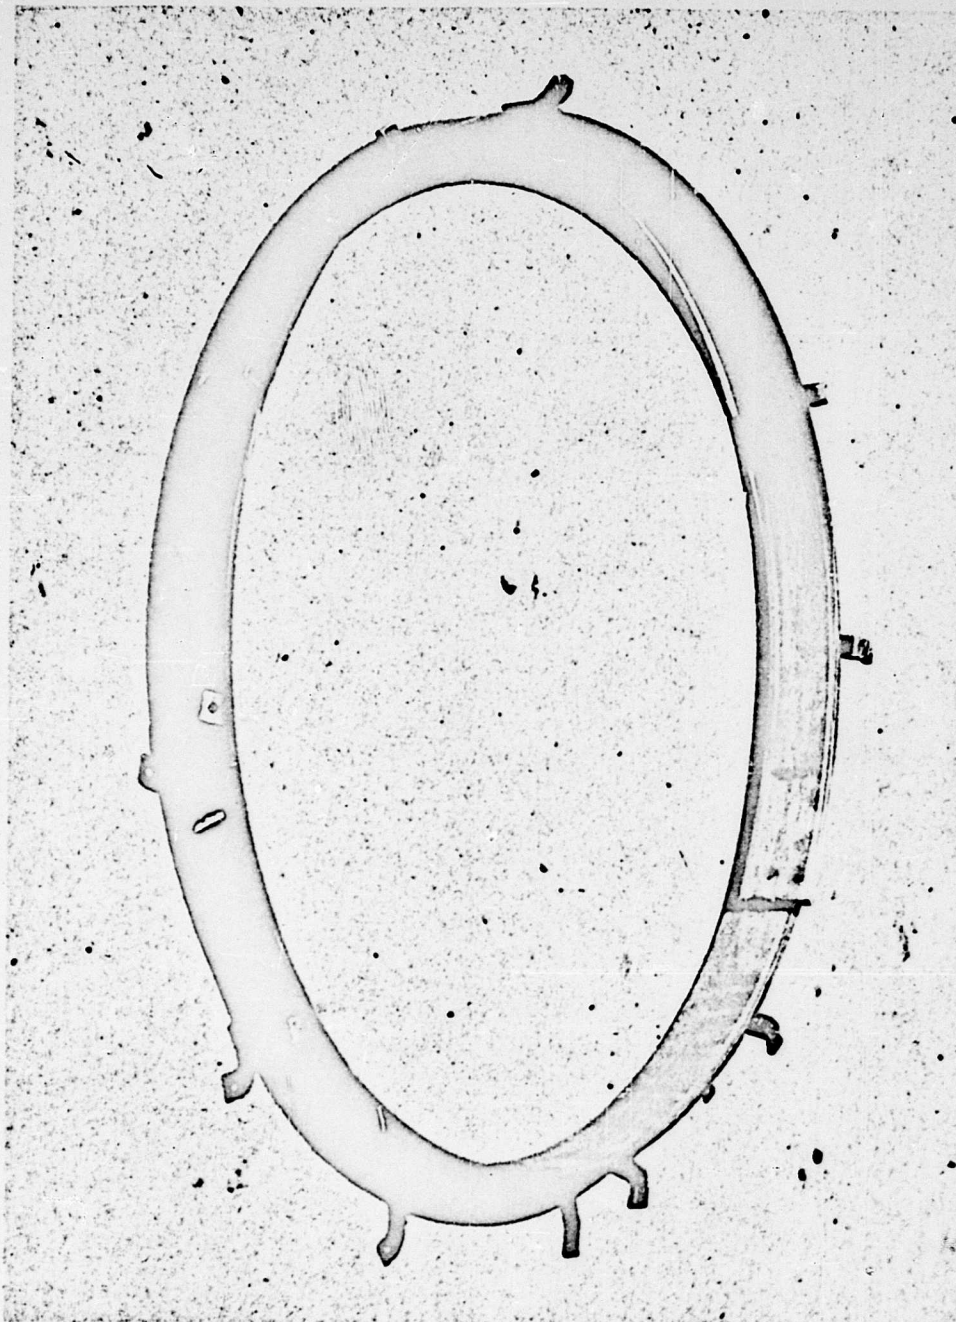
Figure VI-20

During this initial testing it was also noted that the turbine rotor shroud was distorted. The cause of this was believed to be that the fabricating vendor had not properly stress relieved the part after welding. As a result of this distortion higher tip clearances existed.

FAILED TURBINE ROTOR SHROUD

1. Redesign turbine shroud of test vehicle.
2. Revise location of compressor bleed air for stator coolant air flow.
3. Continue the engine test program to demonstrate operation at 2500°F average turbine inlet temperature.

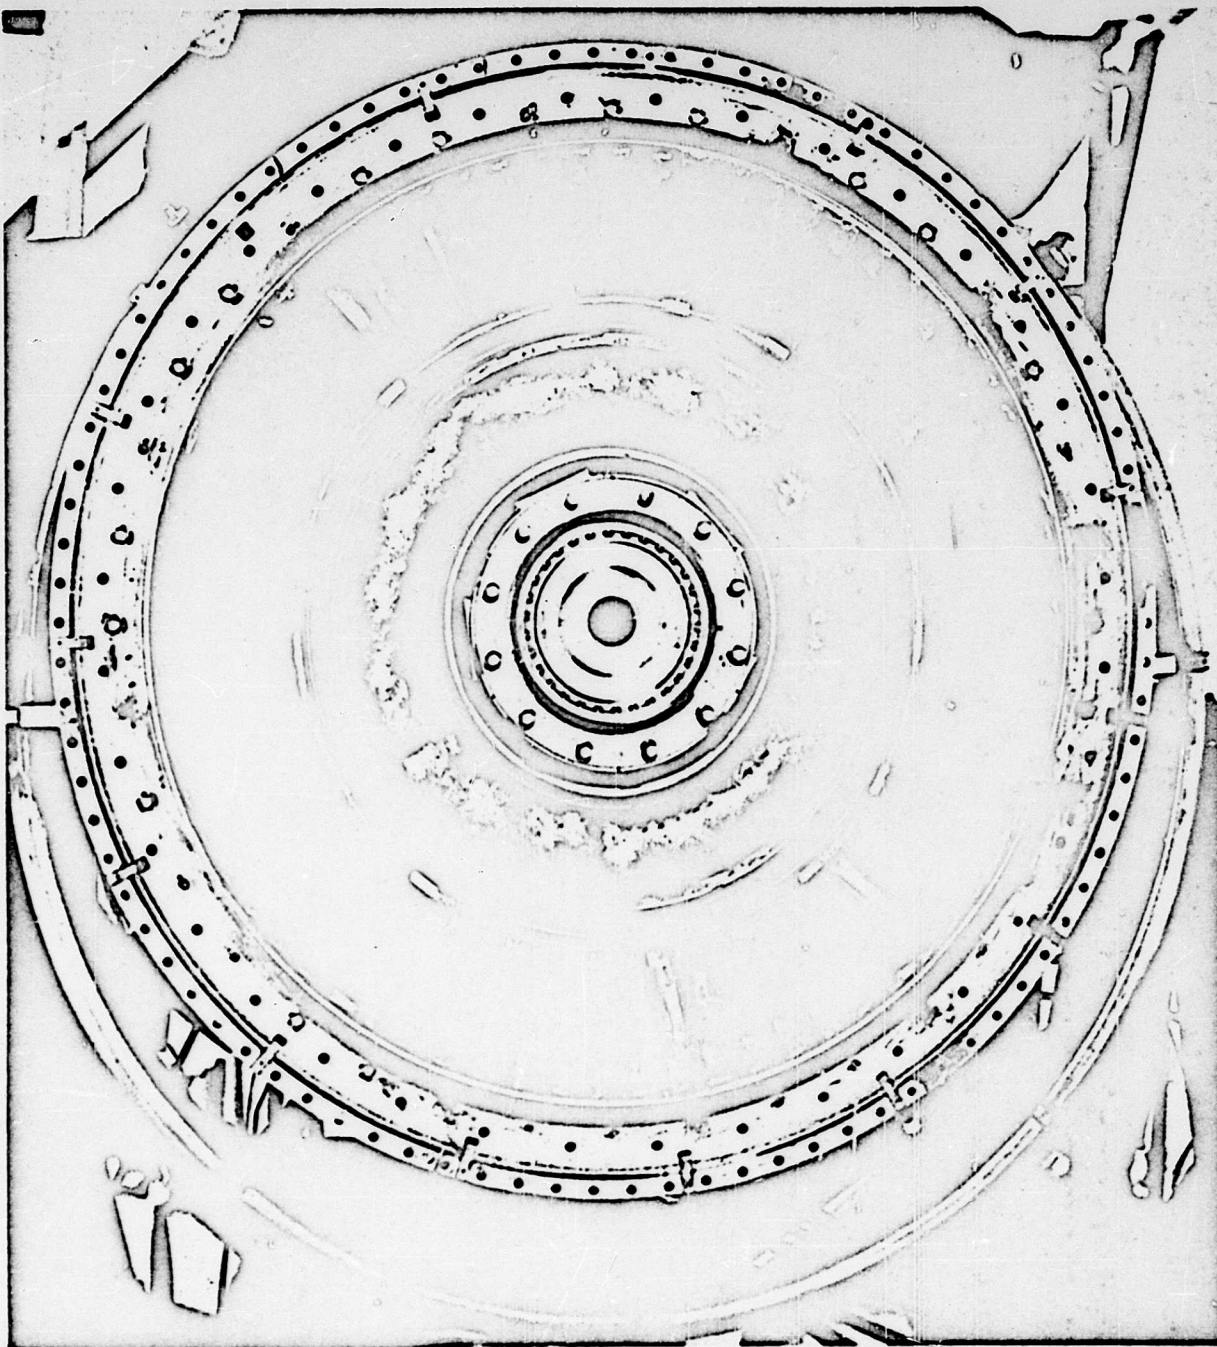
Figure VI-21

Inspection also revealed that the condition of the transpiration cooled stator blades after these tests was excellent, and they only suffered minor secondary damage as can be seen in Figure VI-21. The effectiveness of the masking of the blades at the root section on the suction side was definitely proven by the condition of the blades by the apparent change in cooling air flow to the more critical areas of the blade airfoil surfaces.

TRANSPIRATION COOLED STATOR BLADE ASSEMBLY
AFTER FAILURE OF TURBINE SHROUD RING
